# BARRIERS TO FISH MIGRATION IN UPPER RIVER ALMOND, LOTHIAN REGION

12 MARCH 2008

By Dr Andy Walker, Fishery Consultant (ex FRS Freshwater Laboratory)

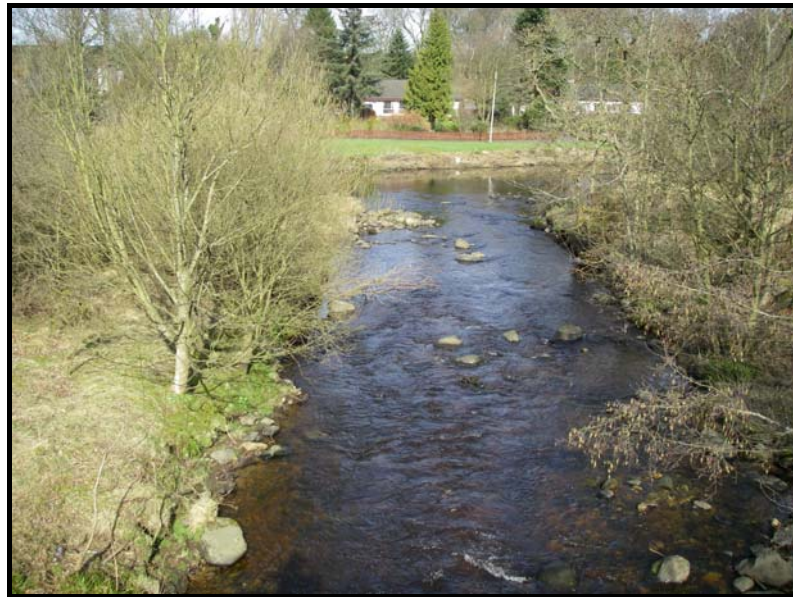
**Plate I: Linhouse Water near its confluence with the River Almond by Mid Calder**

We looked briefly at the lower sections of the Linhouse Water and the Murieston Water, or Bog Burn (Plates I&II) which, as already stated, have good water quality and probably contain much of the better spawning and nursery habitat for both salmon and trout in accessible parts of the upper catchment of the Almond. Paul commented that the Murieston Water is more significant than it might seem for it holds its flow level better than the Linhouse, although appearing to be much smaller on OS maps.

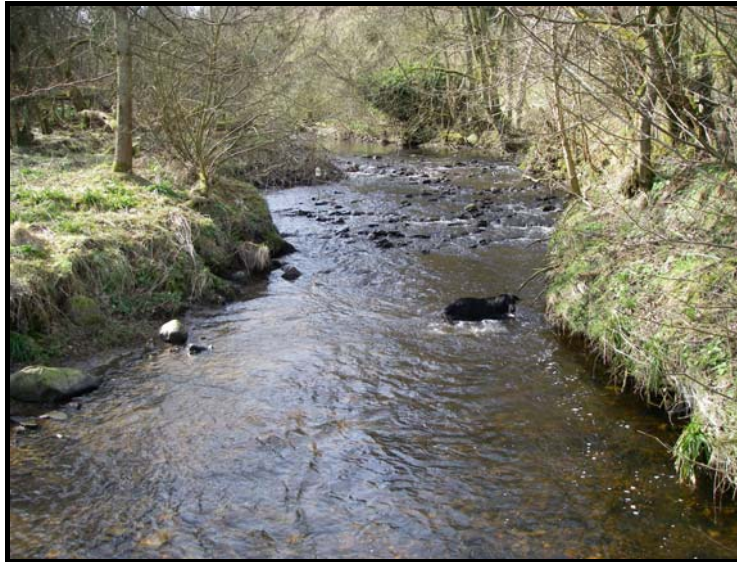
**Plate II: Murieston Water (Bog Burn) which joins the Linhouse near its confluence with the River Almond**

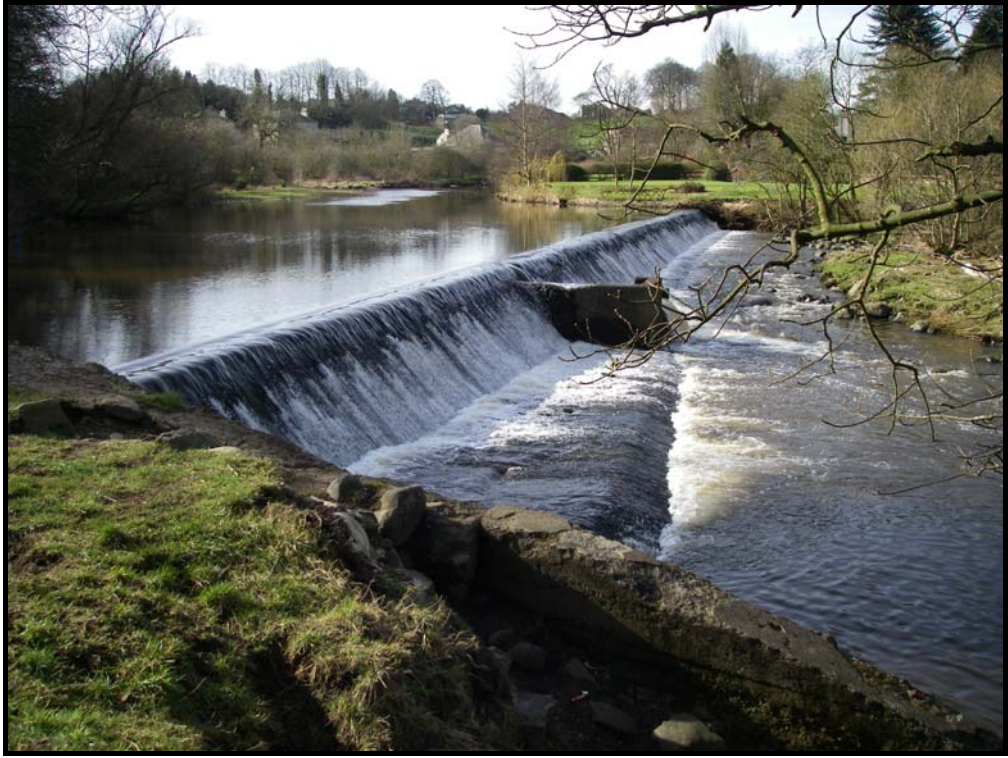
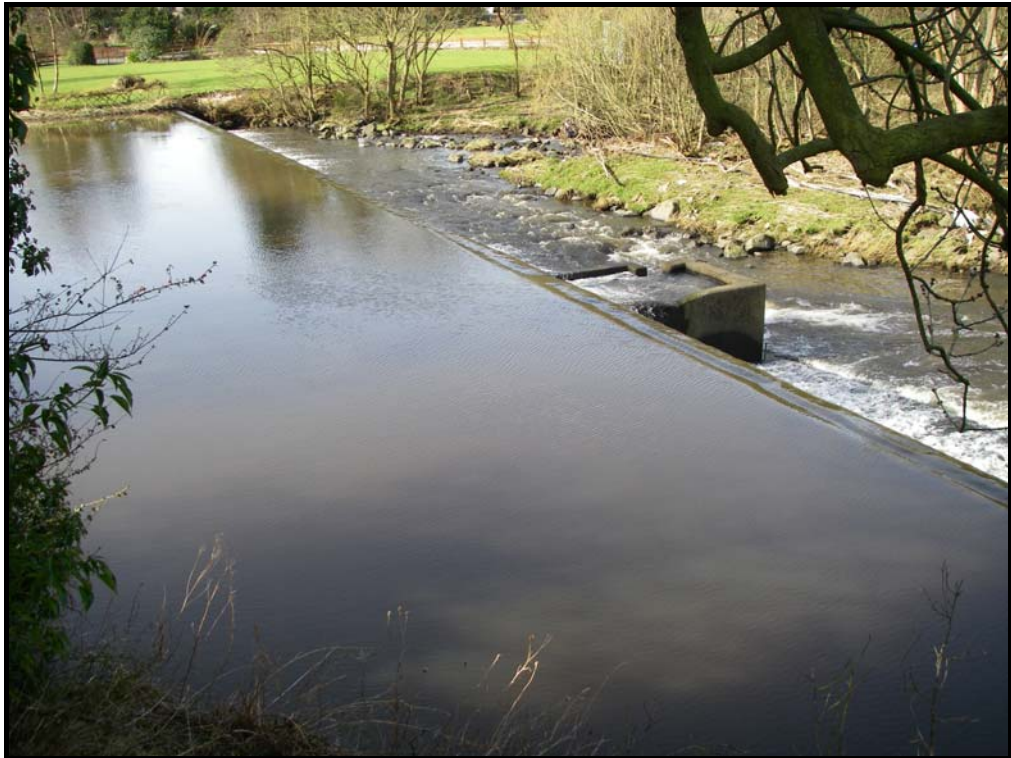
Mid Calder Weir is a significant barrier in the River Almond situated a few hundred metres below the mouth of the Linhouse Water. Indeed, Buchanan *et al* (2008) state that this is the most formidable barrier in the catchment. Salmon and trout can ascend in spates, but it causes them significant delay and probably physical damage and is a great gathering place for poachers from September onwards during the back-end salmon run. Water falling over the sloping weir face, which is some 2 metres or more in vertical height, runs onto a wide concrete apron, providing little depth for running or jumping fish, unless the river is very high. A simple concrete box fish pass arrangement is set in the middle of the weir but, according to Buchanan *et al*, only about 5% of the fish are seen trying to enter this. However, it is possible that the pass works better at some water heights when fish may be able to pass through unseen. According to Reid (1985), the weir was impassable until 1978, when the fish pass was installed by the then Almond Angling Association (now defunct), with assistance from Lothian Regional Council. Sea trout used it immediately and salmon were expected to do likewise. Paul Buchanan commented that he sees sea trout jumping at the extreme left bank of the weir where it is less high (looking downstream). Near the right bank, erosion of the apron has provided extra depth and therefore more amenable conditions for salmon and they can be seen lying there as they make their way upstream. Unfortunately, these fish are in reach of poachers with landing nets and in need of greater protection. It is commonly observed that salmon and trout often jump at different parts of falls and other obstructions. Swimming and leaping potential are related to body size, but there may also be some species-specific requirements for fish ladder performance. Most fish passes in common use in the UK have been designed to be used by salmon.

**Plate III: Mid Calder Weir**

**Plate IV: Mid Calder Weir**

As there are doubts about the effectiveness of the fish pass, consideration should be given to opening or removing the weir, which appears to serve no purpose now. The loss of the pool upstream which is popular for trout fishing is one disadvantage. Also, the exposed bed would be raw and unsightly until naturally re-vegetated. If the weir is retained, a slot could be cut in the lip above the eroded portion of the apron, to create more flow at that point and provide further encouragement to upstream movement of fish near the right bank (looking downstream). Another possibility is to construct a fish pass in the channel of the now derelict lade (same side), although it would need to be fenced or covered as protection from poachers. Yet another is to modify the existing box pass to reduce the individual fall and straighten the flow by adding one or more boxes. The present arrangement appears to make the fish jump to enter and then turn at right-angles to reach the next level, in water that may be excessively turbulent (and see Plate XI). [Designs known to be effective include the Pool and Weir Pass, the Denil, the Alaskan Steeppass (modified Denil), the Vertical Slot Pass, the Uniform Gradient (simple ramped) Pass and the Diagonal Baulk Pass (see “Notes for Guidance on the Provision of Fish Passes and Screens...” (Anon,1995)). Shallow ramped passes are used in the Island of Funen, Denmark to overcome functioning or heritage site weirs where it is important not to lose the head of water. These roughened ramps, essentially mimicking a natural cobbled substrate in order to break up the flow, are cut through the weirs at an intermediate height to project out into the head pond, thus maintaining a shallow slope while keeping the entry point as close as possible to the foot of the weir.] Specialist engineering advice may have to be sought but the ultimate choice of ladder design could depend on overall costs. Anon (1995) provides estimated costs for construction of about £25k/m head for pool and weir passes and £15k/m for modular Denils (1994 prices). As the weir is already passable, there may be considerable savings in modifying the existing ladder or the points on the weir near the right bank where fish are known to get through successfully, such as the eroded section by the right bank. However, the fabric of the weir may be becoming undermined by erosion and further work could exacerbate the breakdown of the structure.

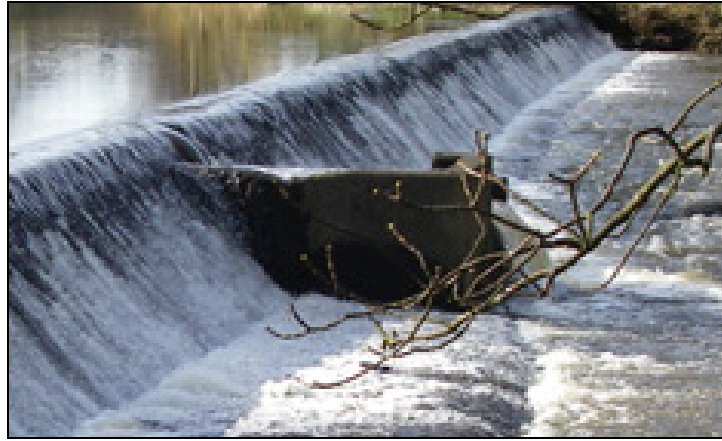
**Plate V: Box-type fish pass at Mid Calder Weir (Plate III enlarged)**

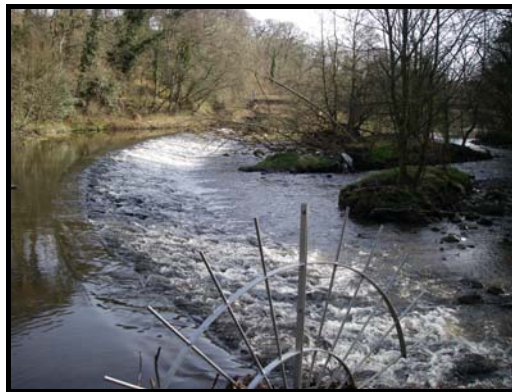
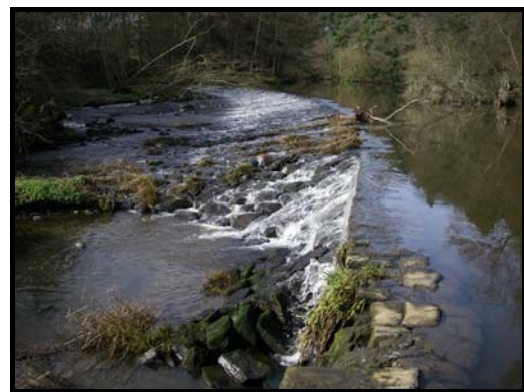
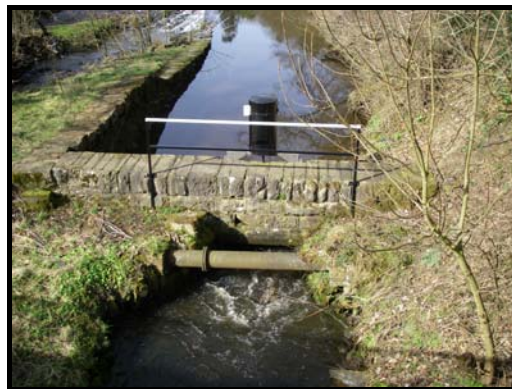
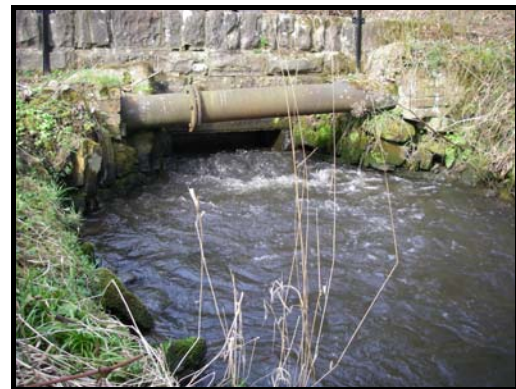
The next obstruction visited was the one below the sewage works downstream from Mid Calder. A long, curving, largely cobbled, structure, this one provides river water for the Union Canal via a sluice into an unscreened lade. It seems likely that a proportion of the descending salmon and sea trout smolts and brown trout find their way along the weir face and into the canal where they may be eaten by pike. Although the entrance is unscreened, there is a legal requirement for a smolt screen to be installed at its entrance (The Salmon (Fish Passes and Screens) (Scotland) Regulations 1994). Also, there should be a bypass overspill near the screen to divert back to the river any fish that are attracted along the face of the weir. There is a bypass of sorts, either intended or due to gradual breakdown of the weir wall, but it is too far away from the lade intake to be effective as a fish diversion. {Screen designs are shown in Notes for Guidance on the Provision of Fish Passes and Screens for the Safe Passage of Salmon (Anon 1995).}

Much of the cobbled, shallow-sloping weir itself appears readily passable by ascending fish in high water conditions, although the lack of a deeper section in the face and the rather broad and shallow water immediately below the weir are unhelpful. Depth could be increased below the weir by removing some of the loose cobbles that have accumulated over time, even using these to back-up a pool beneath. It is assumed that the weir will be retained as a means of supplying water to the canal. Nevertheless, it ought to be possible to dish the face over a short section near the main flow at the right bank to help upstream migration. Increased velocities of water at this point may then scour out a better channel for fish to approach the weir.

**Plates VI & VII: Views of the lower Mid Calder weir and lade**

**Plates VIII & IX: More Views of the lower Mid Calder weir and lade**

The law also specifies that only sufficient water for the purpose intended should be taken by individual lades. Buchanan *et al* (2008) comment that the canal might be drawing too much water. There is a sluice to control the flow but no obvious signs of monitoring equipment. Concerns about abstraction levels should be addressed to SEPA to deal with under the new CAR regulations.

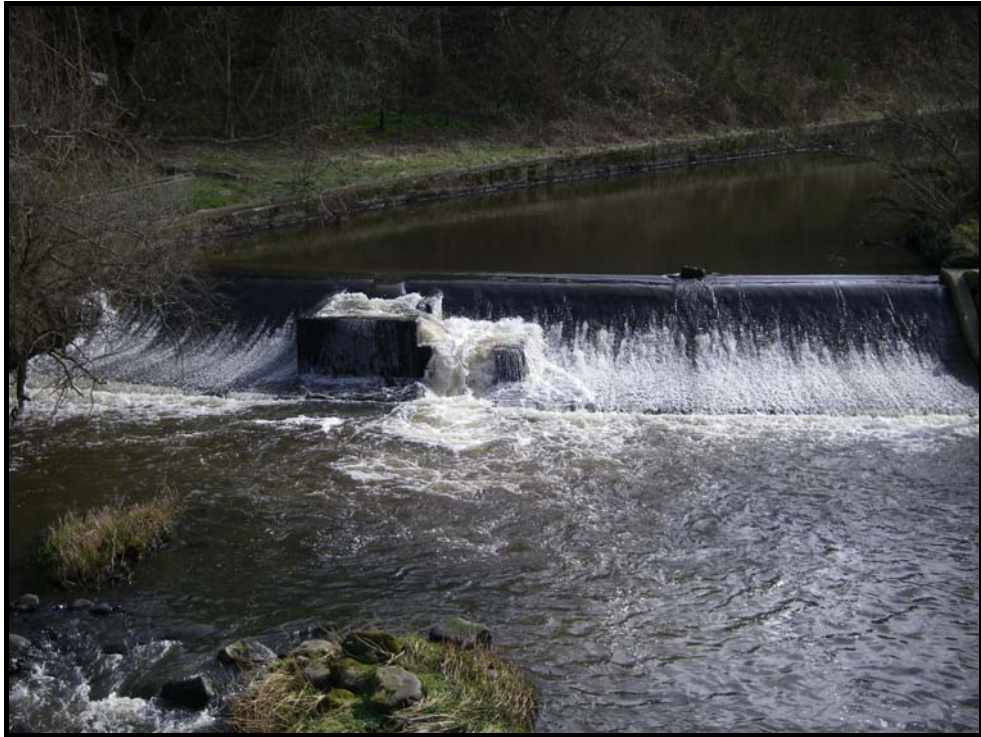
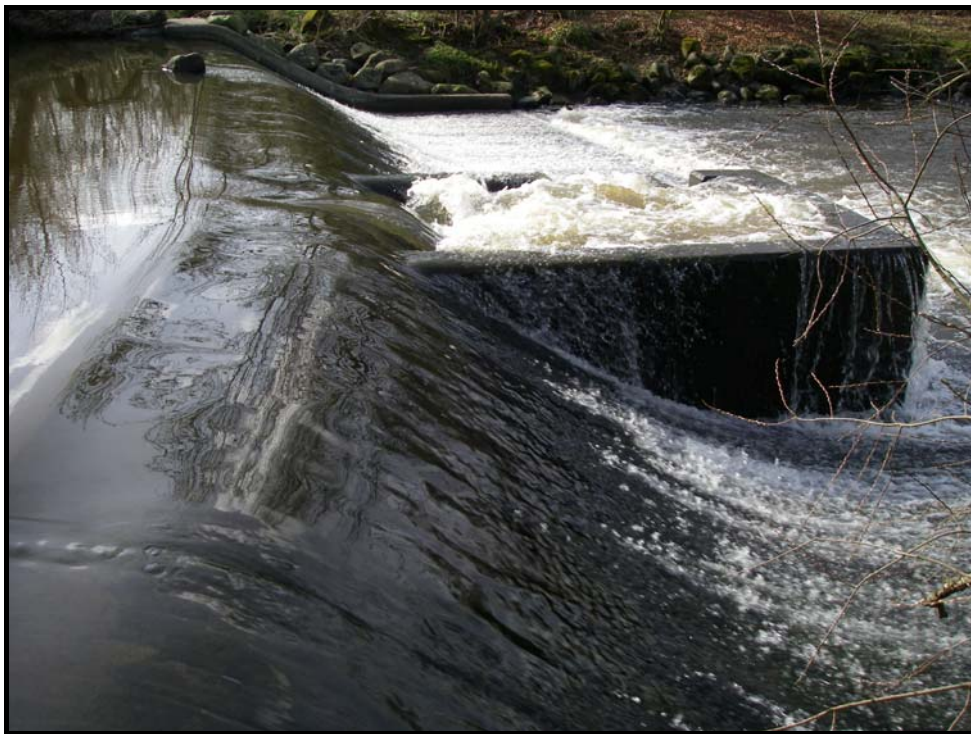
The weir near Livingston Rugby Club has a similar, but smaller, box fish pass to the one on Mid Calder Weir. Most of the steeply inclined weir face and platformed base are likely to present serious problems for ascending fish, however trout can ascend near the right bank. Paul said that the fishing pool above is excellent for brown and sea trout and felt that the weir should be retained for this reason, although he was uncertain whether salmon made it past here in numbers. As at Mid Calder, the right-angled box sections of the ladder create turbulence which may hamper fish movement. Paul's observations here were that the bulk of the fish tried to ascend outside rather than through the ladder. It would be difficult visually to assess whether movements through the boxes take place at some river levels without an electronic fish counter or video camera. There is scope to improve fish passage at this weir, as at Mid Calder, although its removal would be more certain to assist salmon.

**Plate X: Weir at Livingston Rugby Club**

**Plate XI: Weir at Livingston Rugby Club**

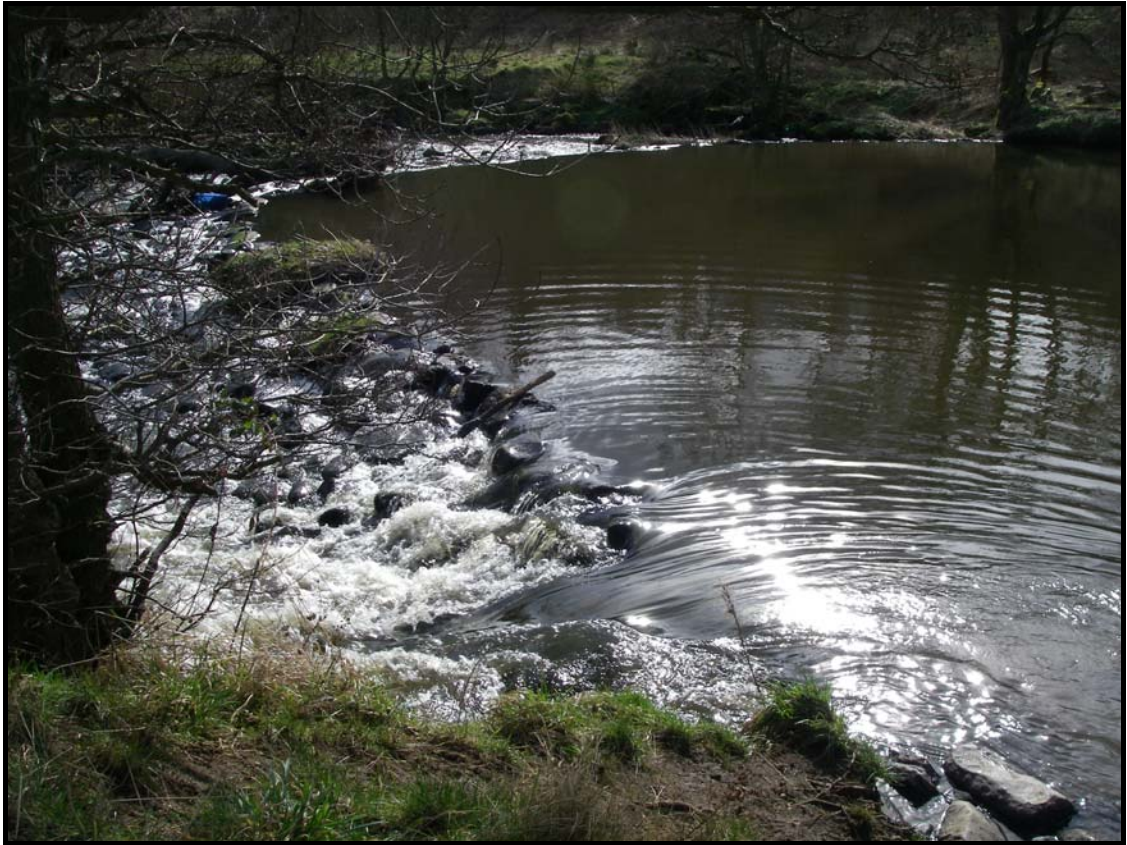
Another shallow, cobbled weir upstream has a very long, curved span so that the lip is very shallow over most of this length. According to Paul, in the early 1980s, Livingston Newtown Angling Club (also now defunct) tried to remove some cobbles at the top of the weir, but had limited success. However, we found that a section has recently broken through near the left bank and the more concentrated flow in that area has scoured out a deeper channel, making it easier for fish to ascend. This simple rubble weir seems to be breaking down and is not the awkward barrier that it used to be.

**Plate XII: Curved, cobble weir also near the Rugby Club**

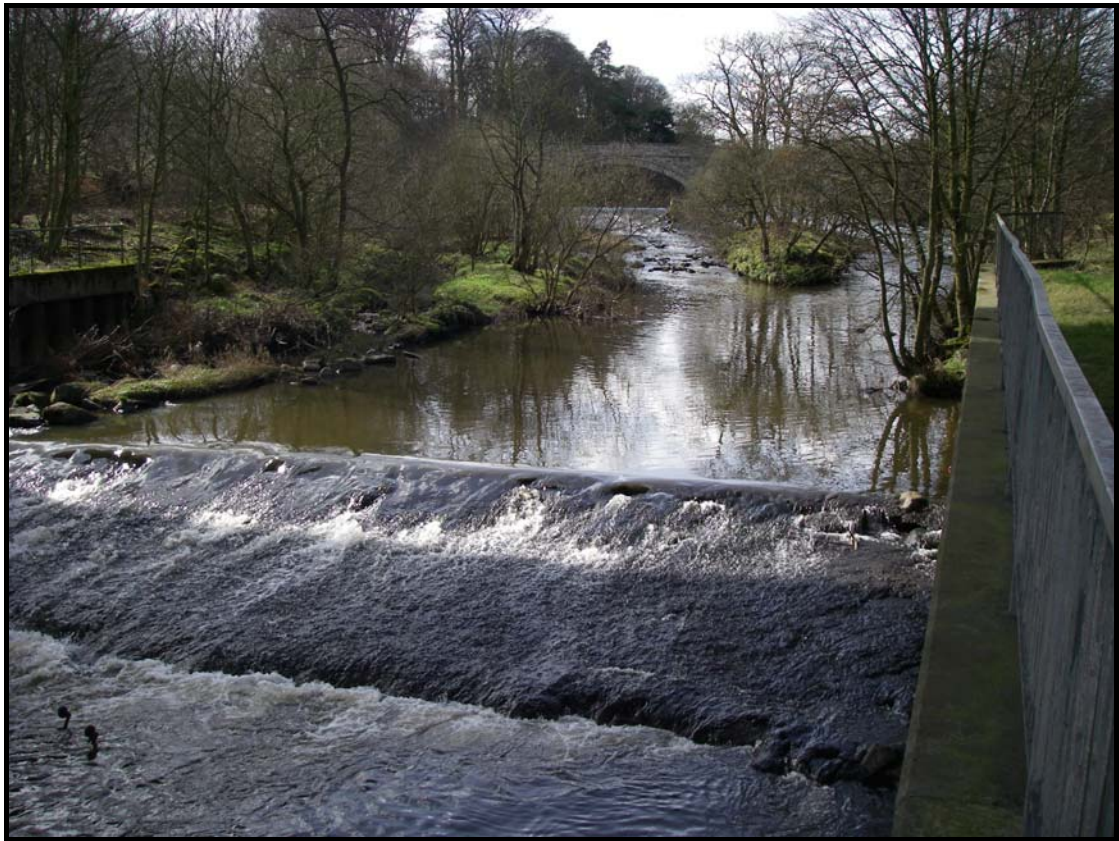
Further upriver, we inspected a small weir below Almond Valley Bridge where there was no indication of any consideration for migratory fish passage. However, Paul said that fish appear to pass it without difficulty when the river is high, at which times it is almost inundated by the flow. Even so, it ought to have a dished section to assist passage at lesser flows. The most suitable point for this would be at the right bank (not shown), where the flow is already broken by some boulders, although this work would be of a low priority if fish are able to pass relatively easily. However, they then encounter a shallow pool and a difficult run up to the next weir.

**Plate XIII: Weir below Almond Valley Bridge**

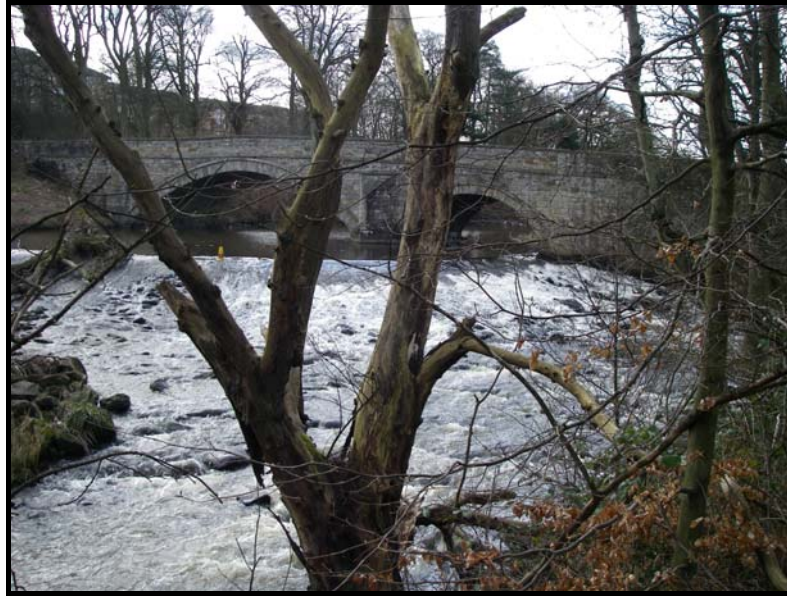
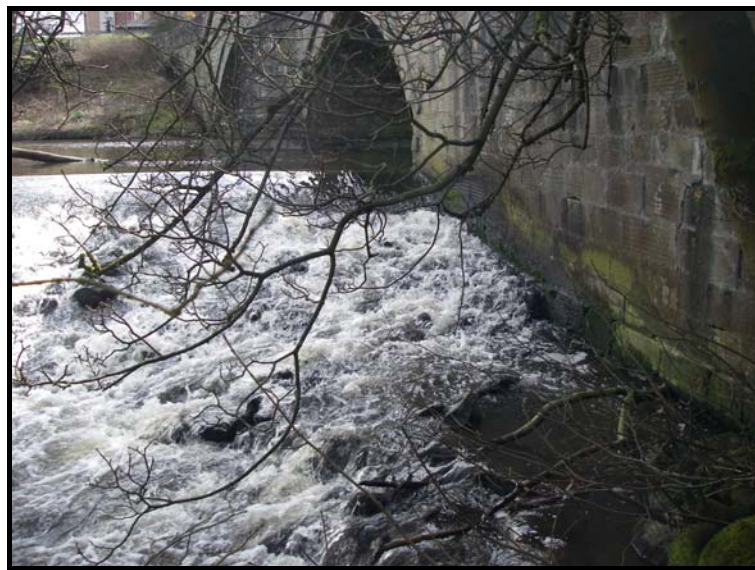
The next weir, not far upstream and below an older bridge, comprised a long curved structure with a substantial overall slope and thinly dispersed water coming down it. The full width of the weir is not shown below (Plates XIV&XV)

**Plate XIV: Weir below Almondvale Flats (a)**

**Plate XV: Weir below Almondvale Flat (left bank)**

Salmon and perhaps also trout are likely to have difficulty passing this structure, because of the shallow approach and curved crest. Paul said that as far as he knew there have been no reports of salmon caught above this point, although one of the largest tributaries of the Almond, the Breich Burn, is only a few miles upstream. (However, the Breich Burn still suffers from water quality problems due to former mining). The best approach to the weir for migrating fish would seem to be near the left bank (looking downstream) and ideally a slot should be created there by removing some of the crest of the weir close to the bridge. Flow enhancement here should scour a deeper channel immediately downstream and the scouring process could be encouraged if necessary by removing some of the bed during dry weather. Work on the crest of the weir should be done with care in case of damage to the integrity of the foundations of the bridge. However, this modification should be fairly simple to accomplish and should help the fish get past, even though there is a worse barrier not much further up.

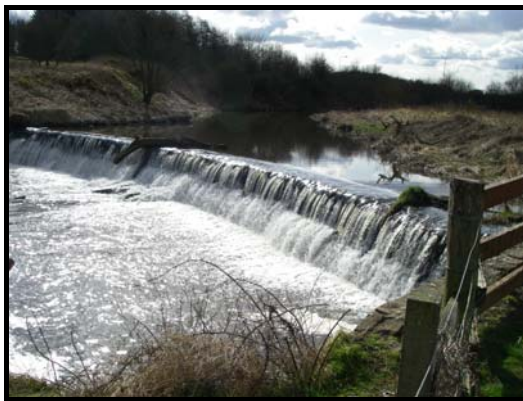
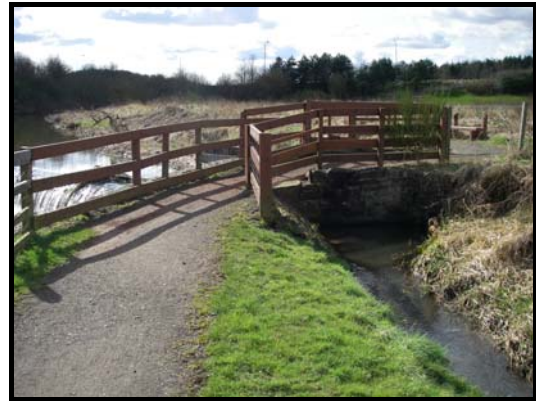
The next weir upstream (Plates XVI&XVII) diverts water via a lade to Mill Farm, which has a pond and a working water wheel. Again, no salmon have been reported above this weir which lacks a fish ladder and appears impassable. The vertical height is about two metres and the water discharges into a relatively shallow pool with concrete and rubble base, offering little opportunity for migrating fish to leap to any significant height. A ledge about halfway down the otherwise vertical face of the weir causes a secondary spray that would be another complicating factor for leaping fish. The Breich Burn, a potentially important spawning tributary, is only about a mile upstream. The lade has a sluice to control the flow but is unscreened. If migratory fish were allowed to get upstream past this weir there could be a need for a screen at the lade entrance and bypass for kelts and smolts etc. It may be argued that the water flowing through the lade eventually falls back into the river, so any fish moving downstream in its flow would do likewise. On the other hand, harm could be caused to the fish by the pond or more likely the water wheel arrangements which were not inspected during the advisory visit. However, Buchanan *et al* (2008) suggest in any case that salmon and trout do not reach Mill Farm Weir at present based on lack of evidence of fish jumping there on days when they can be seen jumping at weirs further downriver. If improvements can be made for fish passage at these lower weirs there will eventually be a need for a fish ladder at Mill Farm Weir. At the same time, the pool beneath it will need to be deepened. However, it would be advisable to carry out a biological and barrier survey of the Breich Water and other areas of the Almond upstream of this weir to assess their suitability and further accessibility for spawning and then for fry and parr production before installing a fish pass at Mill Farm Weir.

**Plates XVI & XVII: Mill Farm Weir and Lade**

It should not be overlooked that screening is required at the lade that supplies water from the river to the canal system and may be necessary at Mill Farm Weir, if migratory fish are permitted to pass this barrier. The owners of these and other lades are responsible for the installation and upkeep of such screens.

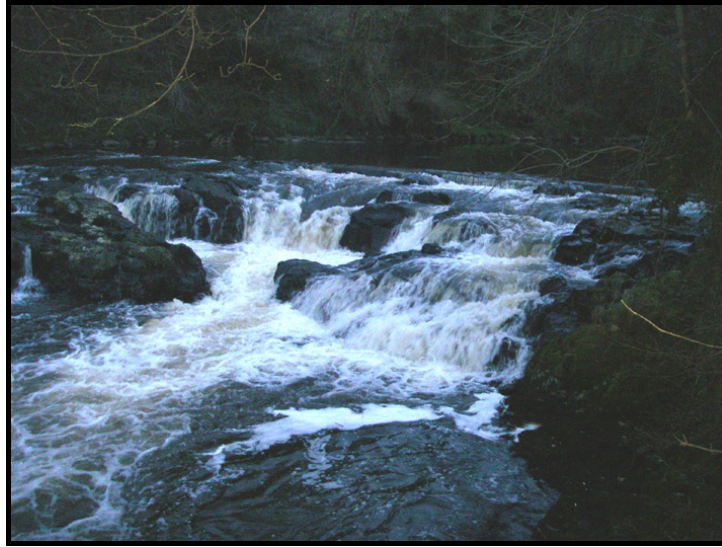
**Plate XVIII: Natural Shelf at Morton Hall with concreted lip**

The complex broken rock shelf at Morton Hall is passed by both salmon and trout and has a number of fissures and other potential routes for upstream-migrant fish to proceed at a range of flows. The concreted top lip, intended to raise the height slightly to help divert flow through a lade on the left bank, is now redundant and could be removed in places, or completely, although it may not affect fish passage at times of reasonable river flow.

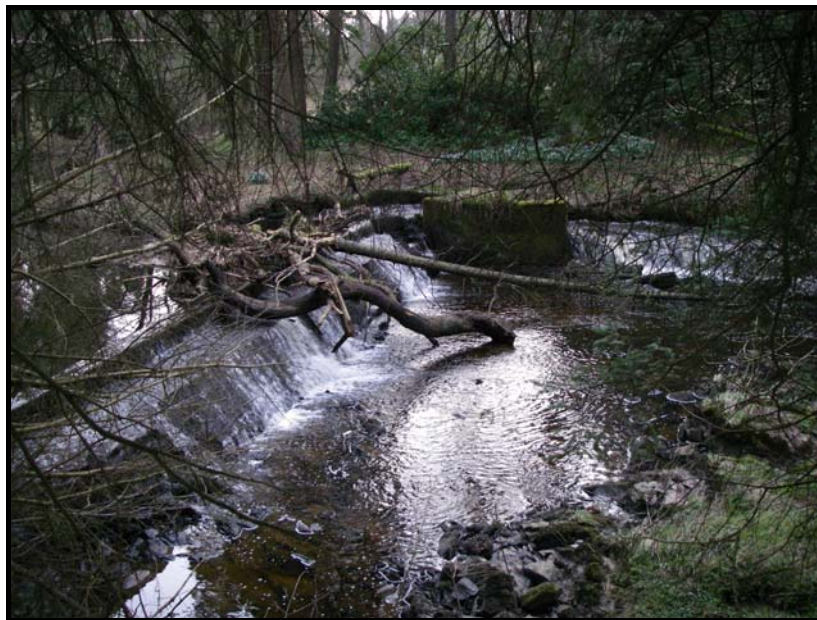
**Plate XIX: Derelict weir on the Linhouse Water (upstream of a significant natural barrier)**

As the Linhouse Water is one of the cleanest of the Almond tributaries, it is particularly important to identify any artificial barriers to fish movements there. There is a derelict weir (Plate XIX) at Linhouse that could be removed, however a natural waterfall downstream by Mortonhill (Plate XX) bars appears to block migrating fish, therefore work to remove the weir may be unnecessary. It may be possible to ease these falls by blasting, but the counter argument is that the areas of stream upstream of the falls will contain established isolated brown trout stocks and other fauna

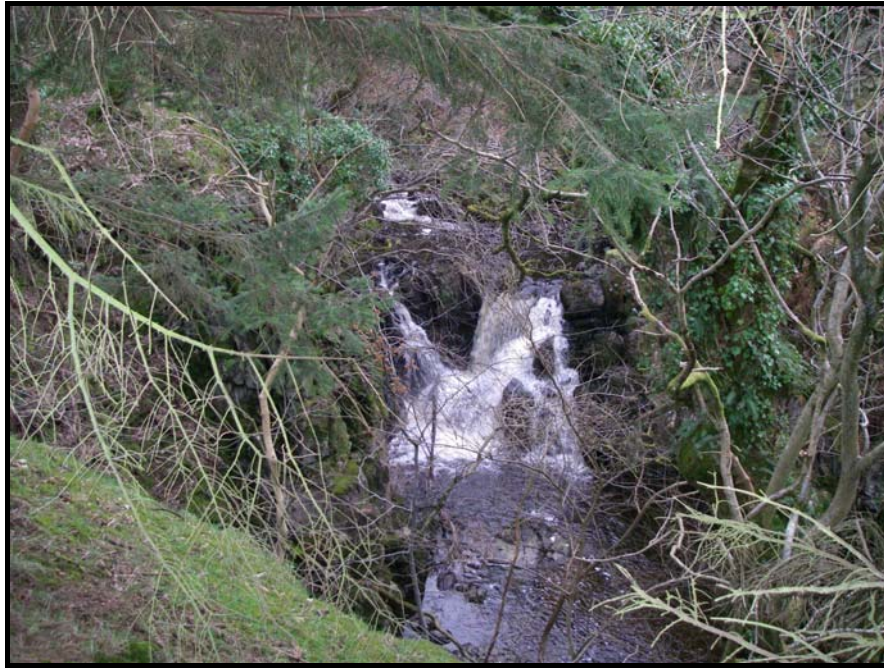
that could be genetically modified or lost if additional migratory fish are given access. Similarly, stocking of salmon or sea trout could be carried out above the falls but the use of above-falls areas for stocking in order to enhance stocks of migratory fish is seen increasingly as bad practice from a conservation viewpoint.

**Plate XX: Natural waterfall on Linhouse Water**
