**THE RIVER ANNAN DISTRICT**

**SALMON FISHERY BOARD**

**Assessment of Man-made Barriers to Fish Migration in the River  
Annan Catchment**

**March 2011**

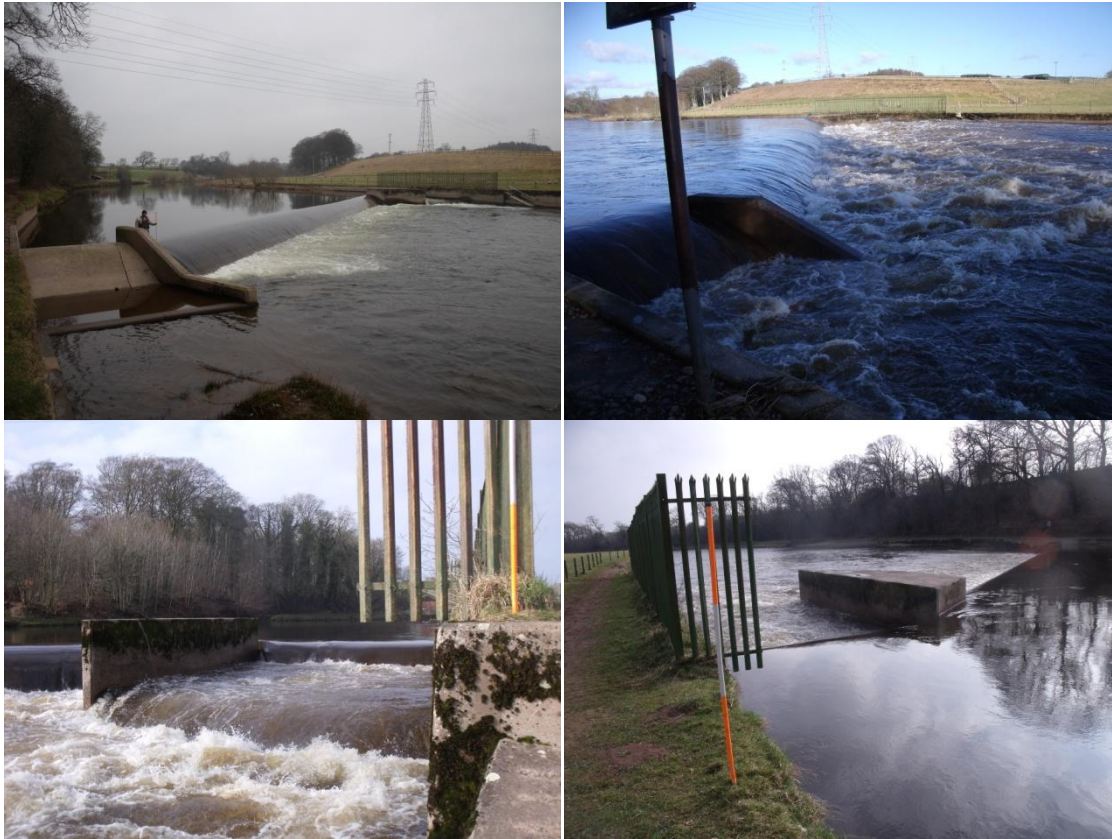
**Figure 3.1**

The majority of structure An1 was deemed impassable due to the height and gradient of the weir as shown in Figures 3.1 a) and b). Figure c) does not show rectangular notches which are present but obscured at both the forefront and rear of the fish pass. These notches allow for the upstream passage of adult Atlantic salmon (*Salmo salar*), brown/sea trout (*Salmo trutta*) and grayling (*Thymallus thymallus*) possibly as a low impact barrier. It is estimated that the fish pass represents a high impact barrier to cyprinids and juvenile salmonids and a complete barrier to adult lampreys due to water velocities. Juvenile eels (*Anguilla Anguilla*) may utilise climbing substrate at either end of the weir. It was considered that downstream migration was not an issue for any cohort of fish. It should be noted that this structure could not be measured for velocities or depths and the above estimates are purely subjective.

An1 (main-stem Annan: E319009N568229): Final Passability Assessment

Fish Type & Conditions	U/S Impact	U/S Estimation	D/S Impact	D/S Estimation
AS – low water	1.0	MPU	1.0	MPU
AS – elevated	1.0	AME	1.0	AME
AS – bankfull	1.0	AME	1.0	AME
AT – low water	1.0	MPU	1.0	MPU
AT – elevated	1.0	AME	1.0	AME
AT – bankfull	1.0	AME	1.0	AME
AG – low water	1.0	MPU	1.0	MPU
AG – elevated	1.0	AME	1.0	AME
AG – bankfull	1.0	AME	1.0	AME
C/JS – low water	0.3	MPU	1.0	MPU
C/JS – elevated	0.3	AME	1.0	AME
C/JS – bankfull	0.3	AME	1.0	AME
AL – low water	0.0	MPU		
AL - elevated	0.0	AME		
AL – bankfull	0.0	AME		
JE – low water	1.0	MPU		
JE - elevated	1.0	AME		
JE – bankfull	1.0	AME		
SS – low water			1.0	MPU
SS - elevated			1.0	AME
SS – bankfull			1.0	AME
JL – low water			1.0	MPU
JL - elevated			1.0	AME
JL – bankfull			1.0	AME
AE – low water			1.0	MPU
AE - elevated			1.0	AME
AE – bankfull			1.0	AME

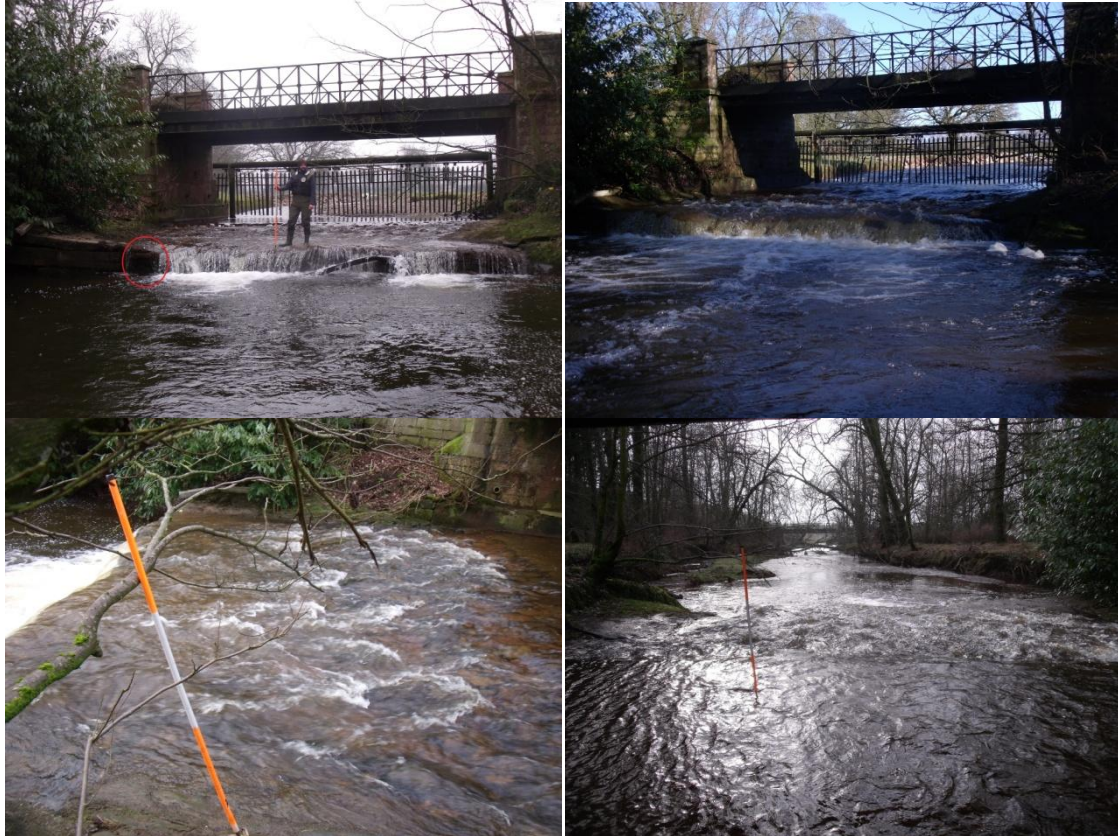
**Figure 3.2**

*Photographs of structure MN1 looking upstream at a) low water and b) elevated level. Figures c) and d) were taken at elevated level and show a side elevation and downstream view respectively*

The vertical leap in the forefront of figure 3.2 a) and b) shows little difference in height between low water and elevated level. This jump was recorded as no barrier for adult salmon, a low impact barrier for adult trout and a complete barrier to all other guilds other than juvenile eels which may utilise the climbing substrate circled in Figure 3.2 a). The sloping weir beyond this was a complete barrier at low water to the upstream migration of adult salmon, adult trout, adult grayling and cyprinids mainly due to shallow water. It was estimated that variable combinations of water depths and velocity made this a low impact barrier for these guilds at elevated level. The effective length of the structure made it either a low or high impact barrier to the other cohorts at any water level. In summary, only adult salmon and trout and juvenile eels are likely to migrate upstream of both the leap and slope to some extent. For these guilds (adult eels rather than juvenile) migration downstream is likely to be best attempted at higher water levels. One or two rocks at the bottom of the vertical drop recorded this as a low impact barrier.

**MN1 (Mein Water: E320612N574454): Final Passability Assessment**

Fish Type & Conditions	U/S Impact	U/S Estimation	D/S Impact	D/S Estimation
AS – low water	0.0	AMU	0.0	AMU
AS – elevated	0.6	AME	0.6	AME
AS – bankfull	N/A	N/A	N/A	N/A
AT – low water	0.0	AMU	0.0	AMU
AT – elevated	0.6	AME	0.6	AME
AT – bankfull	N/A	N/A	N/A	N/A
AG – low water	0.0	AMU	0.0	AMU
AG – elevated	0.0	AME	0.6	AME
AG – bankfull	N/A	N/A	N/A	N/A
C/JS – low water	0.0	AMU	0.0	AMU
C/JS – elevated	0.0	AME	0.6	AME
C/JS – bankfull	N/A	N/A	N/A	N/A
AL – low water	0.0	AMU		
AL - elevated	0.0	AME		
AL – bankfull	N/A	N/A		
JE – low water	0.3	AMU		
JE - elevated	0.3	AME		
JE – bankfull	N/A	N/A		
SS – low water			0.3	AMU
SS - elevated			0.6	AME
SS – bankfull			N/A	N/A
JL – low water			0.6	AMU
JL - elevated			0.6	AME
JL – bankfull			N/A	N/A
AE – low water			0.3	AMU
AE - elevated			0.6	AME
AE – bankfull			N/A	N/A

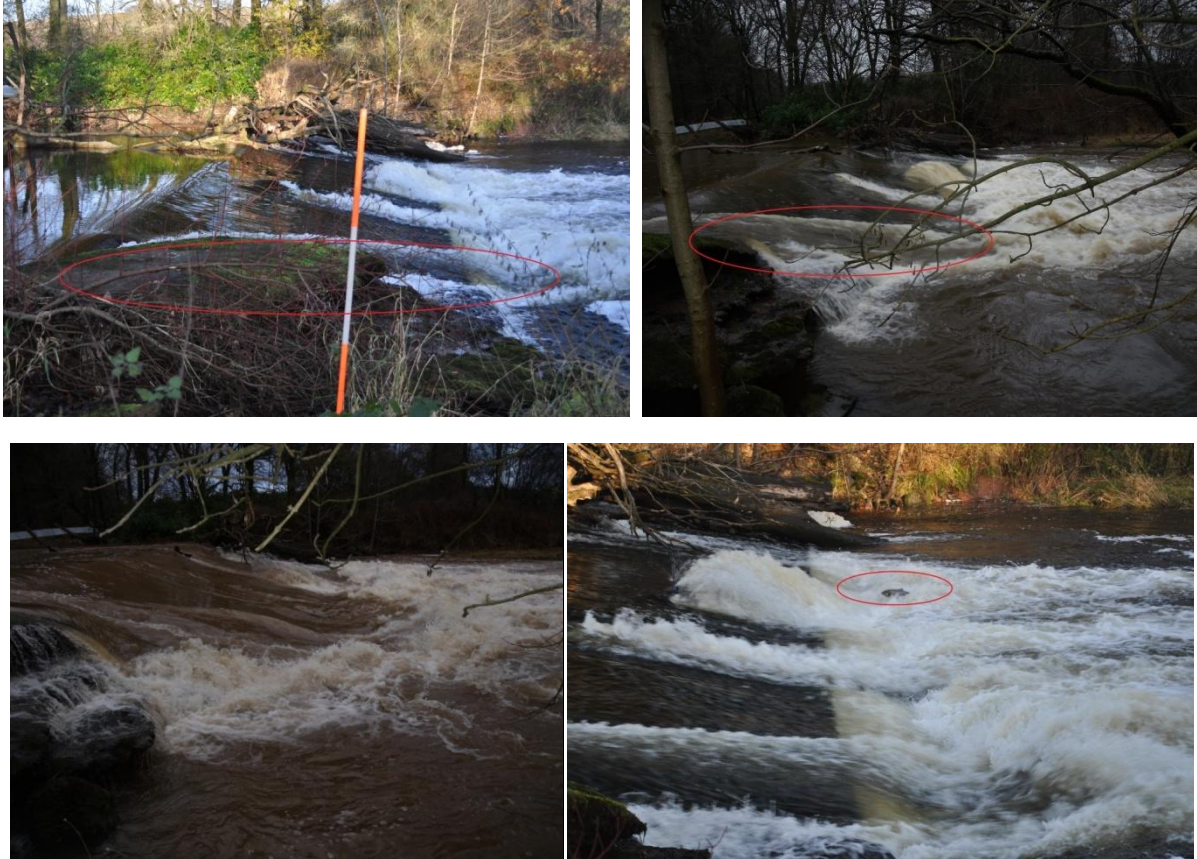
**Figure 3.3**

*Photographs of barrier MK1 at a) low water b) elevated level c) bankfull level and d) bankfull level looking upstream*

The data deemed the barrier to be completely impassable upstream at low water to all cohorts (other than juvenile eels) with shallow water being the main limiting factor. Juvenile eels may utilise suitable climbing substrate on the right bank (circled in Figure 3.1a). The most likely route upstream for adult salmon and trout (supported by anecdotal evidence) appears to be the right bank area at elevated levels (Figure 3.1b) although turbulence and water velocity should make this a barrier for weaker and smaller fish. It seems unlikely that adult grayling, adult lampreys, cyprinids or juvenile salmonids can pass at elevated level. The barrier appears to be impassable to all cohorts upstream at bankfull level due to water velocity and turbulence as shown in Figure 3.1c. Figure 3.1 d shows a small adult salmonid attempting to jump what is essentially a swim barrier at elevated level. It has been recorded that noise associated with the hydraulic jump created at the transition point may attract fish and initiate leaping behaviour (Kemp *et al*, 2008). Around 15 unsuccessful leaps were witnessed by the author at this time. It is highly unlikely that even larger fish would be able to negotiate the obstacle in this manner at any water level. The shallow nature of the structure at low water makes it likely that downstream migration of adult salmon, adult trout, adult grayling, cyprinids and juvenile salmonids is not possible. Juvenile lampreys and adult eels should be able to migrate downstream at all river levels. All cohorts should be able to pass downstream at elevated and bankfull levels.

**MK1 (E314489N574492): Final Passability Assessment**

Fish Type & Conditions	U/S Impact	U/S Estimation	D/S Impact	D/S Estimation
AS – low water	0.0	AMU	0.0	AMU
AS – elevated	0.0	AME	1.0	AME
AS – bankfull	0.3	AME	1.0	AME
AT – low water	0.0	AMU	0.0	AMU
AT – elevated	0.0	AME	1.0	AME
AT – bankfull	0.3	AME	1.0	AME
AG – low water	0.0	AMU	0.0	AMU
AG – elevated	0.0	AME	1.0	AME
AG – bankfull	0.0	AME	1.0	AME
C/JS – low water	0.0	AMU	0.0	AMU
C/JS – elevated	0.0	AME	1.0	AME
C/JS – bankfull	0.0	AME	1.0	AME
AL – low water	0.0	AMU		
AL - elevated	0.0	AME		
AL – bankfull	0.0	AME		
JE – low water	1.0	AMU		
JE - elevated	1.0	AME		
JE – bankfull	1.0	AME		
SS – low water			0.3	AMU
SS - elevated			1.0	AME
SS – bankfull			1.0	AME
JL – low water			1.0	AMU
JL - elevated			1.0	AME
JL – bankfull			1.0	AME
AE – low water			1.0	AMU
AE - elevated			1.0	AME
AE – bankfull			1.0	AME

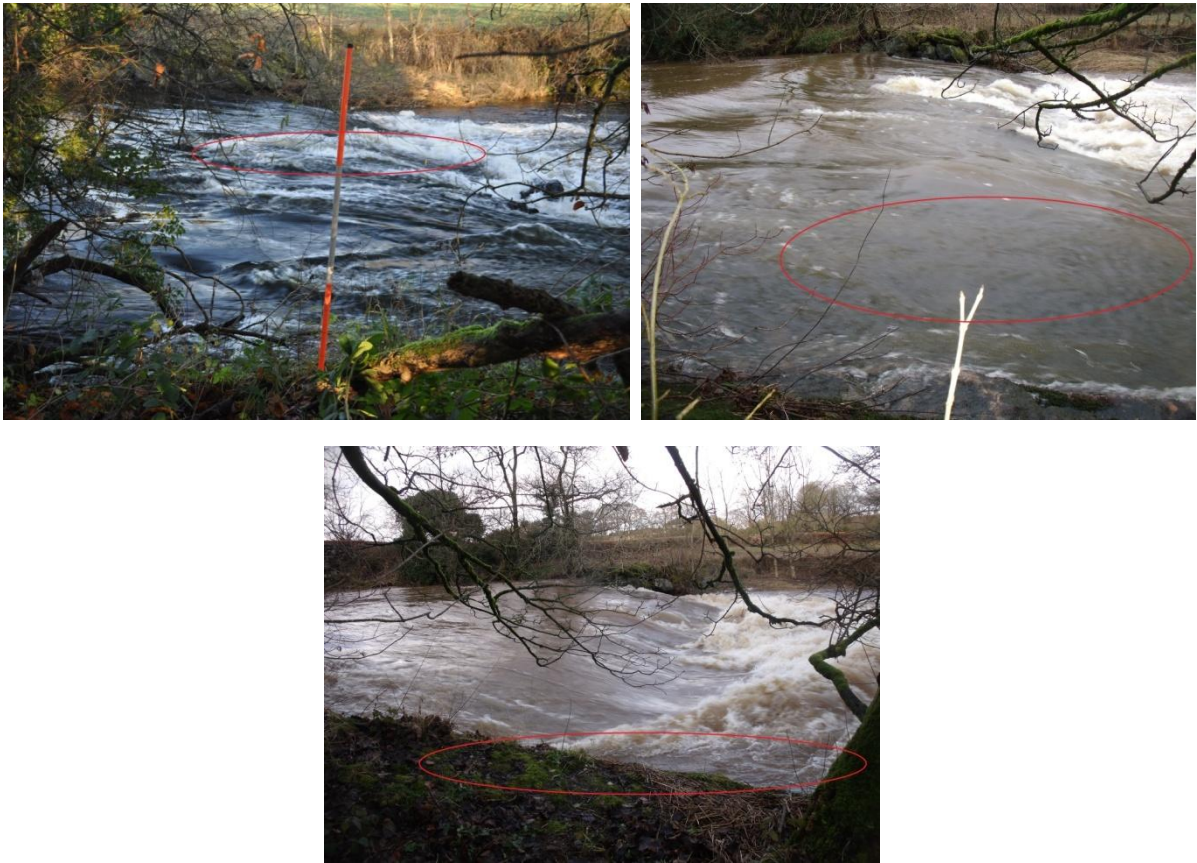
**Figure 3.4**

*Photographs of barrier MK2 at a) low water b) elevated level and c) bankfull level*

There appears to be no barrier to the downstream migration of any cohort at all water levels. The central section circled in Figure 3.2a is around 1.5m in width with a small vertical brick wall running lengthwise either side (obscured in photo). This has created a deeper channel with slower water velocities allowing the upstream migration of fish at low water levels. Water turbulence acts as a low impact partial barrier for adult salmon and trout and a high impact partial barrier for adult grayling. It is unlikely that cyprinids, juvenile salmonids or adult lampreys can pass upstream. It is estimated that only stronger adult salmon and trout can pass upstream at elevated levels within the section circled in Figure 3.2b. The water velocities and turbulence shown in Figure 3.2c appear too great for any cohort to migrate upstream at bankfull level. The exception to this is juvenile eels which may utilise climbing substrate (circled) on the right bank.

**MK2 (E314283N575521): Final Passability Assessment**

Fish Type & Conditions	U/S Impact	U/S Estimation	D/S Impact	D/S Estimation
AS – low water	0.6	AMU	1.0	AMU
AS – elevated	0.6	AME	1.0	AME
AS – bankfull	0.0	AME	1.0	AME
AT – low water	0.6	AMU	1.0	AMU
AT – elevated	0.6	AME	1.0	AME
AT – bankfull	0.6	AME	1.0	AME
AG – low water	0.6	AMU	1.0	AMU
AG – elevated	0.0	AME	1.0	AME
AG – bankfull	0.3	AME	1.0	AME
C/JS – low water	0.0	AMU	1.0	AMU
C/JS – elevated	0.0	AME	1.0	AME
C/JS – bankfull	0.0	AME	1.0	AME
AL – low water	0.3	AMU		
AL - elevated	0.0	AME		
AL – bankfull	0.0	AME		
JE – low water	1.0	AMU		
JE - elevated	1.0	AME		
JE – bankfull	1.0	AME		
SS – low water			1.0	AMU
SS - elevated			1.0	AME
SS – bankfull			1.0	AME
JL – low water			1.0	AMU
JL - elevated			1.0	AME
JL – bankfull			1.0	AME
AE – low water			1.0	AMU
AE - elevated			1.0	AME
AE – bankfull			1.0	AME

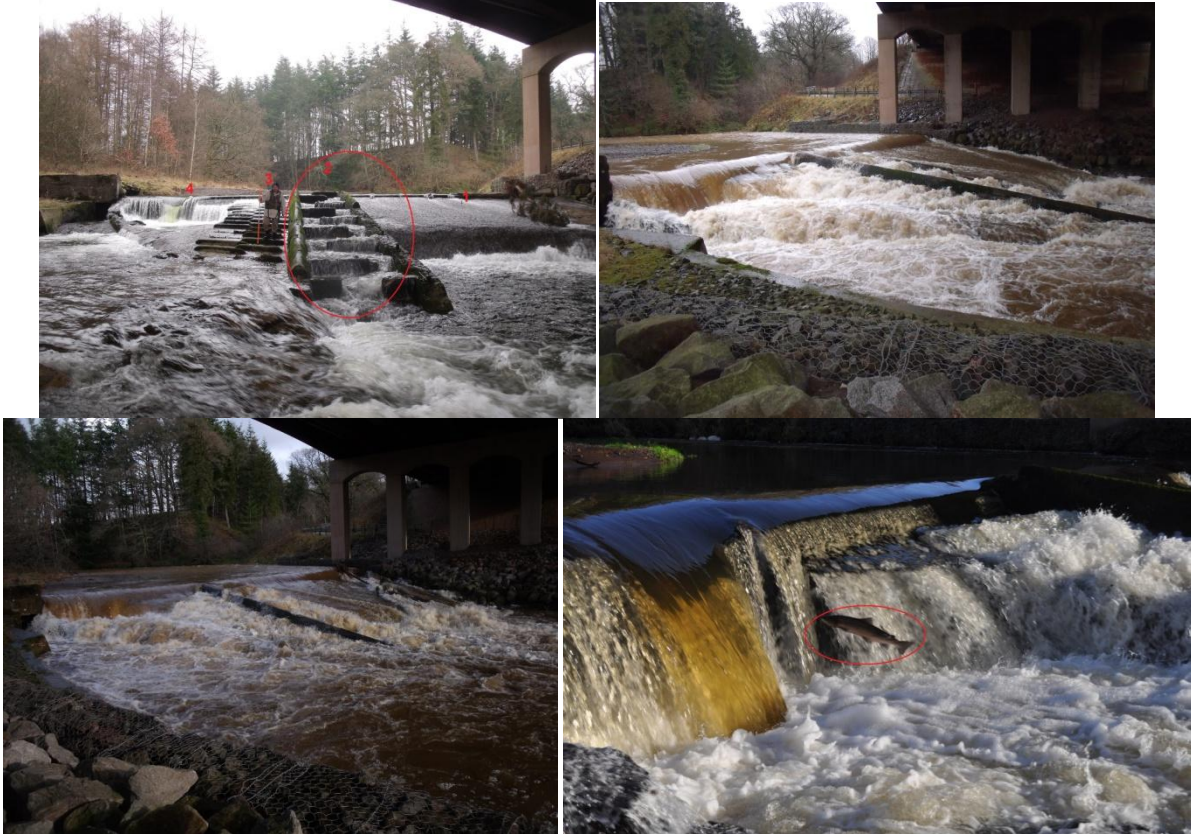
Photos of barrier MK3 looking upstream at a) low water b) elevated level c) bankfull and d) an unsuccessful salmonid leap

The most likely source of upstream migration appears to be transversal section 2 at low water (circled in Figure 3.5 a). Slightly shallow water at the foot of this part of the structure meant it was recorded as a partial low impact barrier for adult salmon, trout and grayling. Water velocity at the foot was assessed as causing a high impact barrier to juvenile salmonids and cyprinids and a complete barrier to adult lampreys. It is likely that high velocities and turbulence make this section impassable to all at elevated and bankfull level. There was climbing substrate present for juvenile eels but the effective length made it a high impact barrier. Transversal section 1 was impassable to all due to a combination of shallow water, velocity and high gradient at the foot of the slope. Transversal section 3 was impassable to all upstream mainly due to sections of little or no water. Transversal section 4 appeared to be impassable to all cohorts due to the height of the vertical jump and very high turbulence below. The author witnessed around 25 attempts by adult salmon to leap this part of the obstruction at elevated level, none of them successful (Figure 3.5d). There were a few points on the structure where downstream migration could be negotiated safely by all guilds.

**Mk 3 (Water of Milk: E315425N578749): Final Passability Assessment**

Fish Type & Conditions	U/S Impact	U/S Estimation	D/S Impact	D/S Estimation
AS – low water	0.6	AMU	1.0	AMU
AS – elevated	0.0	AME	1.0	AME
AS – bankfull	0.0	AME	1.0	AME
AT – low water	0.6	AMU	1.0	AMU
AT – elevated	0.0	AME	1.0	AME
AT – bankfull	0.0	AME	1.0	AME
AG – low water	0.6	AMU	1.0	AMU
AG – elevated	0.0	AME	1.0	AME
AG – bankfull	0.0	AME	1.0	AME
C/JS – low water	0.3	AMU	1.0	AMU
C/JS – elevated	0.0	AME	1.0	AME
C/JS – bankfull	0.0	AME	1.0	AME
AL – low water	0.0	AMU		
AL - elevated	0.0	AME		
AL – bankfull	0.0	AME		
JE – low water	0.3	AMU		
JE - elevated	0.3	AME		
JE – bankfull	0.3	AME		
SS – low water			1.0	AMU
SS - elevated			1.0	AME
SS – bankfull			1.0	AME
JL – low water			1.0	AMU
JL - elevated			1.0	AME
JL – bankfull			1.0	AME
AE – low water			1.0	AMU
AE - elevated			1.0	AME
AE – bankfull			1.0	AME

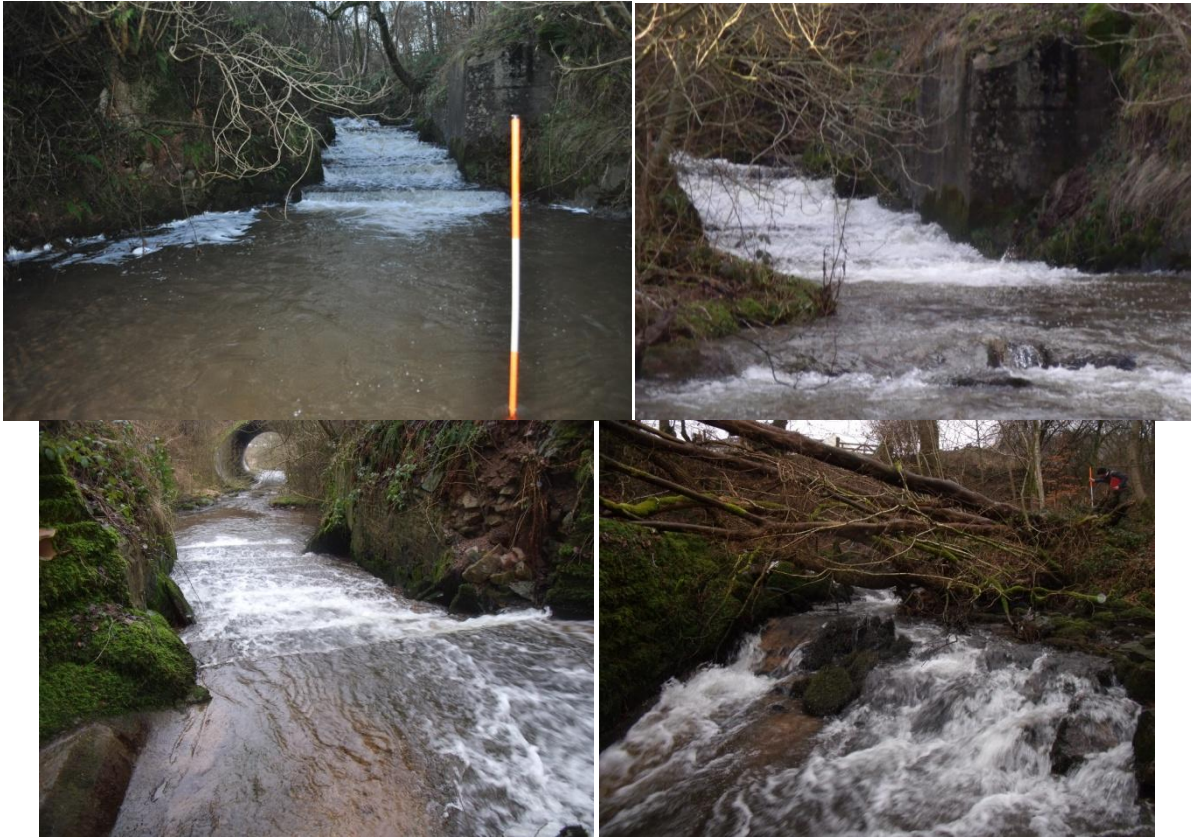
**Figure 3.7**

Photographs of structure DEHT2 looking downstream at a) summer low level and b) bankfull. A downstream view is shown in c) at the elevated level during the survey. Figure d) shows the first of a few natural obstructions immediately upstream

Figures 3.7 a), b) and c) show obstacle DEHT2 at 3 different water levels. The water depths on each step and turbulence levels both across each step and the plunge pool below combine to make the structure impassable both upstream and downstream to all cohorts of fish. The water velocities recorded at elevated level were also a limiting factor for the majority of guilds. Taking into consideration the impassable results of DEHT1 and 2 and the natural obstacles above DEHT2 (Figure 3.7d), it seems certain that no migratory fish will be found in the watercourse above. The Annan DSFB holds limited electrofishing data above these obstacles which yielded 3 juvenile trout and 1 stickleback. It is likely that the trout are resident fish.

DEHT2 (E314523N588908): Final Passability Assessment

Fish Type & Conditions	U/S Impact	U/S Estimation	D/S Impact	D/S Estimation
AS – low water	N/A	N/A	N/A	N/A
AS – elevated	0.0	AMU	0.0	AME
AS – bankfull	0.0	AME	0.0	AME
AT – low water	N/A	N/A	N/A	N/A
AT – elevated	0.0	AMU	0.0	AME
AT – bankfull	0.0	AME	0.0	AME
AG – low water	N/A	N/A	N/A	N/A
AG – elevated	0.0	AMU	0.0	AME
AG – bankfull	0.0	AME	0.0	AME
C/JS – low water	N/A	N/A	N/A	N/A
C/JS – elevated	0.0	AMU	0.0	AME
C/JS – bankfull	0.0	AME	0.0	AME
AL – low water	N/A	N/A		
AL - elevated	0.0	AMU		
AL – bankfull	0.0	AME		
JE – low water	N/A	N/A		
JE - elevated	0.0	AMU		
JE – bankfull	0.0	AME		
SS – low water			N/A	N/A
SS - elevated			0.0	AME
SS – bankfull			0.0	AME
JL – low water			N/A	N/A
JL - elevated			0.3	AME
JL – bankfull			0.3	AME
AE – low water			N/A	N/A
AE - elevated			0.0	AME
AE – bankfull			0.0	AME

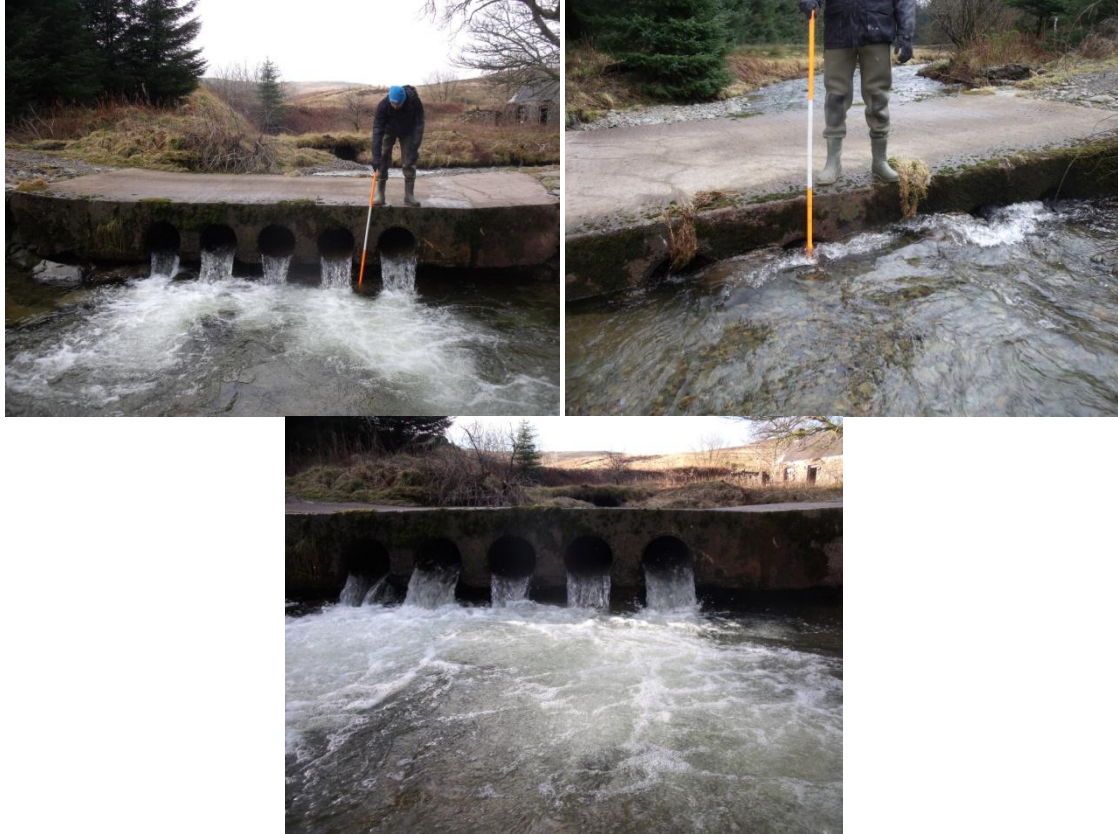
**Figure 3.8**

*Photographs of obstacle De1 at a) Elevated level looking upstream b) elevated level looking downstream and c) Bankfull level looking upstream*

The main limiting factor upstream appeared to be the build up of substrate inside the end of three of the five pipes (observed in Figure 3.8b). This created a small vertical jump which most fish would not be likely to pass without a greater depth of water. This was exacerbated by the creation of smaller openings for the fish to pass through which would be problematic for larger fish. There was an element of chance as 2 of the pipes were relatively clear but the addition of other limiting factors such as turbulence meant the barrier was assessed overall as a high impact barrier to all cohorts upstream. The exception to this is juvenile eels which may utilise climbing substrate. The combination of the vertical leap shown in Figures 3.8a and c and the water velocities and depths within the pipes were measured as having no major impact on any cohort other than adult lampreys, although it is likely that some fish will miss the pipe entrances (possibly damaging themselves in the process) or even end up on the road crossing when leaping. All measurements were taken at elevated levels as shown in Figure 3.8a but there was little difference visually at close to bankfull level as shown in Figure 3.8c. The biggest impact on downstream migration was deemed to be rocks below the downstream end of 2 of the pipes and the barrier was recorded as a low impact barrier for all cohorts. Historical electrofishing data has shown low numbers of juvenile salmonids present above the structure after 2006. Before this there were substantial numbers of juveniles to be found. An extreme flood event in 2006 altered the previously passable structure and surrounding watercourse to their present state.

There may also be certain situations where the subjective assessment of a barrier is correct but the cause of the barrier being inaccessible is not. For example, at barrier DE1 it was the opinion of 3 members of Annan DSFB staff that water velocity through the pipes was likely to be a major limiting factor to all cohorts. Visually this appeared to be the case but flow meter measurements showed that for some fish, e.g. adult salmonids, velocity was not likely to be an issue. If it is the intention to have a barrier removed or altered then it would surely be beneficial to have as much information regarding the limiting factors of a structure before progressing to the next stage i.e. specialist assessment.

**DE1 (E317046N599907): Final Passability Assessment**

Fish Type & Conditions	U/S Impact	U/S Estimation	D/S Impact	D/S Estimation
AS – low water	N/A	N/A	N/A	N/A
AS – elevated	0.3	AMU	0.6	AME
AS – bankfull	0.3	AME	0.6	AME
AT – low water	N/A	N/A	N/A	N/A
AT – elevated	0.3	AMU	0.6	AME
AT – bankfull	0.3	AME	0.6	AME
AG – low water	N/A	N/A	N/A	N/A
AG – elevated	0.3	AMU	0.6	AME
AG – bankfull	0.3	AME	0.6	AME
C/JS – low water	N/A	N/A	N/A	N/A
C/JS – elevated	0.3	AMU	0.6	AME
C/JS – bankfull	0.3	AME	0.6	AME
AL – low water	N/A	N/A		
AL - elevated	0.3	AMU		
AL – bankfull	0.3	AME		
JE – low water	N/A	N/A		
JE - elevated	0.6	AMU		
JE – bankfull	0.6	AME		
SS – low water			N/A	N/A
SS - elevated			0.6	AME
SS – bankfull			0.6	AME
JL – low water			N/A	N/A
JL - elevated			0.6	AME
JL – bankfull			0.6	AME
AE – low water			N/A	N/A
AE - elevated			0.6	AME
AE – bankfull			0.6	AME

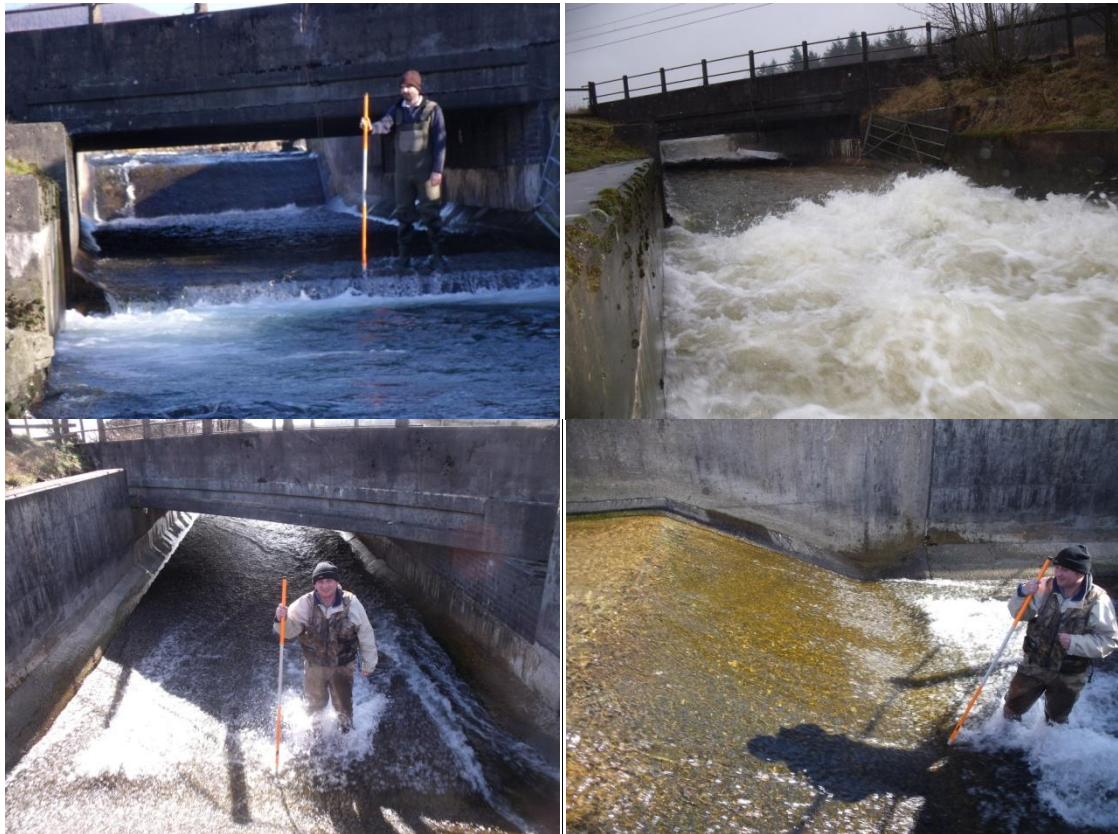
**Figure 3.9**

*The photographs below show barrier WY1 looking upstream at a) low water and b) bankfull levels. Figure 3.9 c) Shows the structure at low water looking downstream and d) shows a side elevation of the higher of the two jump barriers at low water*

The smaller of the two jump barriers within the structure (foreground in Figure 3.9a) is likely to be passable to only adult salmon and trout due to height although the extreme turbulence at higher water levels is likely to act as a low impact partial barrier to these fish. The swim barrier above this is impassable to all guilds at all water levels due to a combination of high velocity, low water depth and effective length. An idea of the velocity on the slope can be seen by the wave created in Figures 3.9 c) and d). In the highly unlikely event that any fish negotiates this part of the obstacle then the jump barrier beyond this (Figure 3.9d) is also impassable due to height, gradient and the lack of any substantial pool to leap from. This assessment is consistent with electrofishing data which has found only juvenile trout (likely to be resident) above the structure other than years following stocking when some salmon fry may be present. The structure is likely to be passable to all cohorts in a downstream direction with a possibility of some damage to larger fish at the bottom of the higher vertical drop due to lack of a reasonable plunge pool.

The barrier WY1 was chosen as priority number one as it excludes all migratory fish from around 95% of one of the Annan's main tributaries. EN1 was number 2 as it excludes all migratory fish from around 6km of good habitat on another main tributary. An1 was third as although it allows access to most migratory fish to some extent it may exclude access to the majority of the Annan catchment for adult lampreys (see section 4.2). MN1, DE1 and ENCN1 were considered to be approximately equal in priority with migratory fish either in very low numbers or absent. MK1 and MK3 appear to act as partial barriers but it is known that there are decent numbers of fish upstream (see section 4.2). DEHT1 and DEHT2 excluded all migratory fish but investigation further upstream showed a number of natural obstructions which are likely to act as barriers. Structure Mk2 was considered to be of least concern.

WY1 (Wamphray Water: E311250N595730): Final Passability Assessment

Fish Type & Conditions	U/S Impact	U/S Estimation	D/S Impact	D/S Estimation
AS – low water	0.0	AMU	0.6	AMU
AS – elevated	0.0	AME	0.6	AME
AS – bankfull	0.0	AME	0.6	AME
AT – low water	0.0	AMU	0.6	AMU
AT – elevated	0.0	AME	0.6	AME
AT – bankfull	0.0	AME	0.6	AME
AG – low water	0.0	AMU	1.0	AMU
AG – elevated	0.0	AME	1.0	AME
AG – bankfull	0.0	AME	1.0	AME
C/JS – low water	0.0	AMU	1.0	AMU
C/JS – elevated	0.0	AME	1.0	AME
C/JS – bankfull	0.0	AME	1.0	AME
AL – low water	0.0	AMU		
AL - elevated	0.0	AME		
AL – bankfull	0.0	AME		
JE – low water	0.0	AMU		
JE - elevated	0.0	AME		
JE – bankfull	0.0	AME		
SS – low water			1.0	AMU
SS - elevated			1.0	AME
SS – bankfull			1.0	AME
JL – low water			1.0	AMU
JL - elevated			1.0	AME
JL – bankfull			1.0	AME
AE – low water			1.0	AMU
AE - elevated			1.0	AME
AE – bankfull			1.0	AME

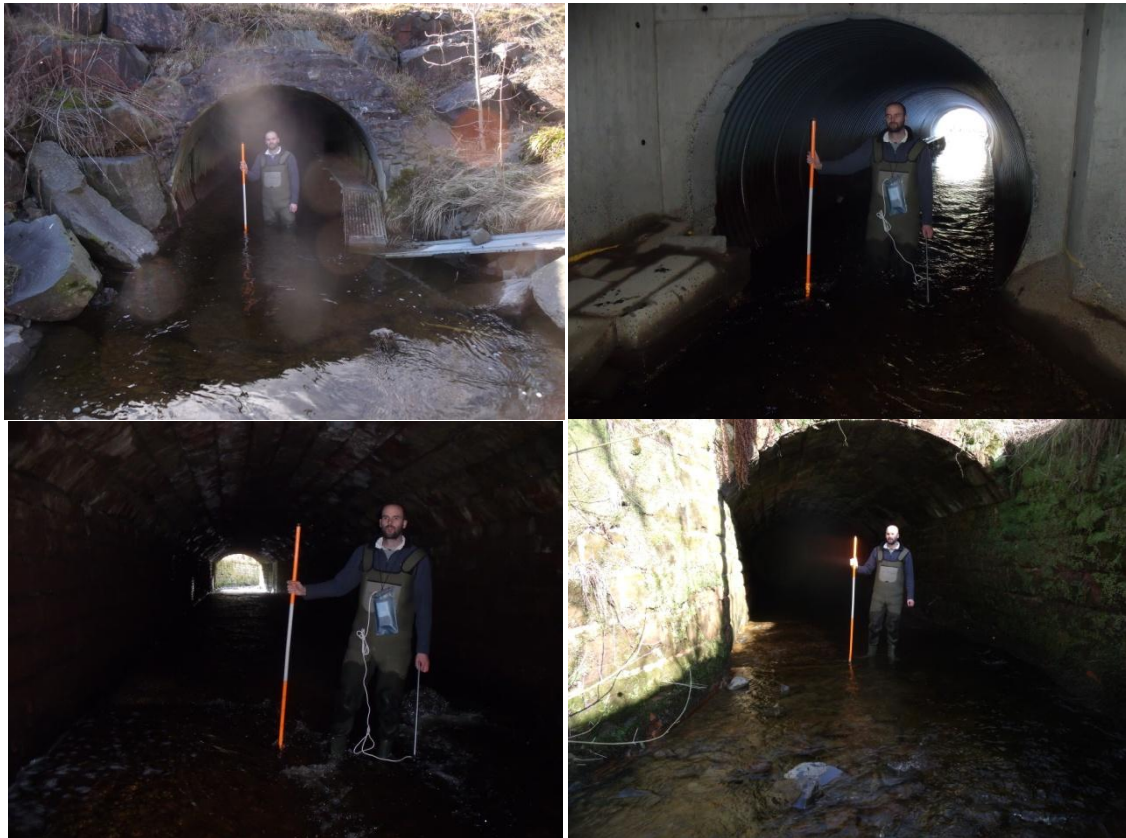
**Figure 3.10**

*Photographs of barrier ENCN1 at low water a) lower culvert upstream b) lower culvert downstream c) upper culvert upstream and d) upper culvert downstream.*

Although barrier ENCN1 was a single transversal section it consisted of two continuous but very different culverts. It was decided to score these as individual transversal sections to assess the differences between them. Figures 3.10 a) and b) show the lower culvert which had good water depth and low velocities which would be unlikely to hinder any guild moving upstream. The energy expenditure for fish in culvert 1 is likely to be low and the effective length of culvert 1 was not added to that of culvert 2 when assessing this criteria overall. However, the effective length of culvert 2 alone was over 38m and recorded as creating an impassable barrier upstream to all but adult salmon and trout. For adult salmon and trout, water depth and effective length created a complete barrier and high impact barrier scores respectively. Water depth at bankfull level may allow smaller salmon to pass upstream and so the structure is classed as a high impact barrier at this level. Downstream migration was classed as high impact for adult salmon, trout and grayling, low impact for salmonid smolts and adult eels and no barrier for juvenile lampreys. The impacts are likely to be reduced at higher water levels. The historical electrofishing data for the Cloffin Burn shows juvenile salmon numbers to be very poor and trout densities to be fair using the Annan DSFB grading system. It is unknown what proportion of these trout where spawned from adult sea trout but the figures appear consistent with the barrier assessment.

**ENCN1 (Evan Water, Cloffin Burn: E304856N606635): Final Passability Assessment**

<b>Fish Type &amp; Conditions</b>	<b>U/S Impact</b>	<b>U/S Estimation</b>	<b>D/S Impact</b>	<b>D/S Estimation</b>
AS – low water	0.0	AMU	0.3	AMU
AS – elevated	N/A	N/A	N/A	N/A
AS – bankfull	0.3	AME	0.6	AME
AT – low water	0.0	AMU	0.3	AMU
AT – elevated	N/A	N/A	N/A	N/A
AT – bankfull	0.3	AME	0.6	AME
AG – low water	0.0	AMU	0.3	AMU
AG – elevated	N/A	N/A	N/A	N/A
AG – bankfull	0.0	AME	0.6	AME
C/JS – low water	0.0	AMU	0.6	AMU
C/JS – elevated	N/A	N/A	N/A	N/A
C/JS – bankfull	0.0	AME	1.0	AME
AL – low water	0.0	AMU		
AL - elevated	N/A	N/A		
AL – bankfull	0.0	AME		
JE – low water	0.0	AMU		
JE - elevated	N/A	N/A		
JE – bankfull	0.0	AME		
SS – low water			0.6	AMU
SS - elevated			N/A	N/A
SS – bankfull			1.0	AME
JL – low water			1.0	AMU
JL - elevated			N/A	N/A
JL – bankfull			1.0	AME
AE – low water			0.6	AMU
AE - elevated			N/A	N/A

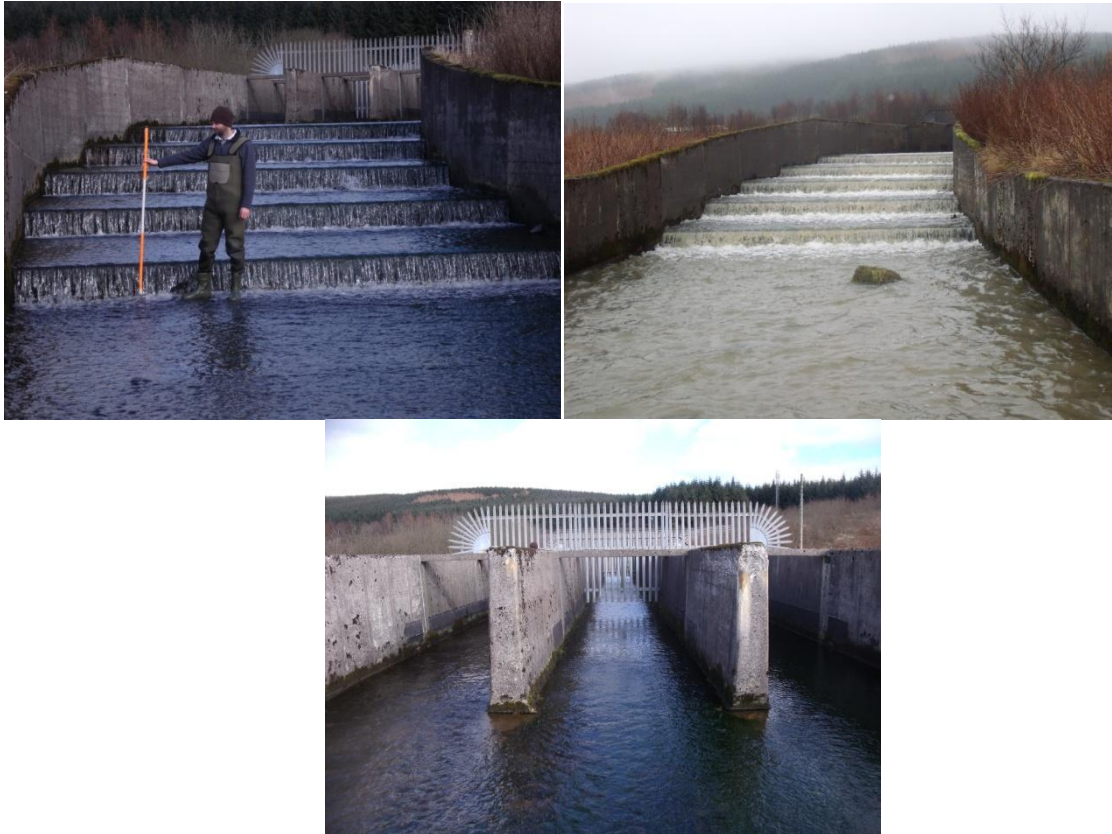
**Figure 3.11**

The photos below show the barrier steps of EN1 upstream at a) Low water and b) bankfull level. Figure c) shows the aquaduct swim barrier above the steps upstream at low water.

The water velocity and turbulence shown in Figure b) at bankfull level is greater than that at low water in figure a). However, there is no great difference in water depth and the lack of any pools to leap from combined with the height of the steps (smaller fish) make this barrier impassable upstream to all cohorts at all water levels. The sloping aquaduct, which crosses the railway line, could not be accessed for its full length due to fencing as displayed in Figure c). Assuming the velocity and depth measurements taken at the accessible section were similar at all sections then a partial barrier would be created for all cohorts both up and downstream apart from juvenile eels. However, due to the length of the slope (estimated at 70m) it is likely that this sloping section is a complete barrier to all upstream migration at any time. The absence of reasonable water depth would also make the aquaduct a high impact barrier for the downstream migration of adult salmon, adult trout, adult grayling and cyprinids and a low impact barrier for adult eels and juvenile salmonids. There would appear to be no downstream barrier for juvenile lampreys.

EN1 (Evan Water: E299973N614373): Final Passability Assessment

Fish Type & Conditions	U/S Impact	U/S Estimation	D/S Impact	D/S Estimation
AS – low water	0.0	AMU	0.3	AMU
AS – elevated	0.0	AME	0.3	AME
AS – bankfull	0.0	AME	0.3	AME
AT – low water	0.0	AMU	0.3	AMU
AT – elevated	0.0	AME	0.3	AME
AT – bankfull	0.0	AME	0.3	AME
AG – low water	0.0	AMU	0.3	AMU
AG – elevated	0.0	AME	0.3	AME
AG – bankfull	0.0	AME	0.3	AME
C/JS – low water	0.0	AMU	0.3	AMU
C/JS – elevated	0.0	AME	0.3	AME
C/JS – bankfull	0.0	AME	0.3	AME
AL – low water	0.0	AMU		
AL - elevated	0.0	AME		
AL – bankfull	0.0	AME		
JE – low water	0.0	AMU		
JE - elevated	0.0	AME		
JE – bankfull	0.0	AME		
SS – low water			0.6	AMU
SS - elevated			0.6	AME
SS – bankfull			0.6	AME
JL – low water			1.0	AMU
JL - elevated			1.0	AME
JL – bankfull			1.0	AME
AE – low water			0.6	AMU
AE - elevated			0.6	AME
AE – bankfull			0.6	AME
